# Operation Practice of Shanghai Maglev Demonstration Line

No. 135

Xiangming, Wu

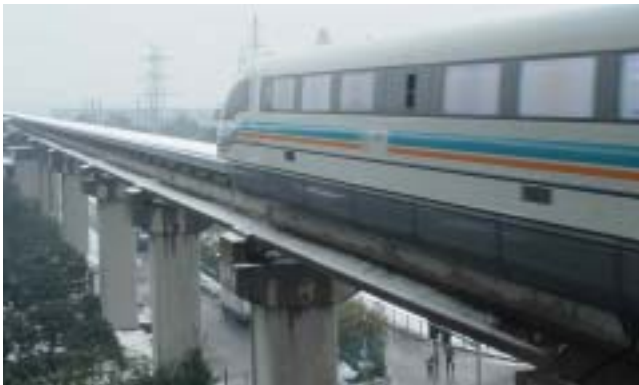
Figure 1. The maglev train's running is not affected by the snow on the guideway.

1) At the end of 2004, Shanghai witnessed a heavy snow that reached 40 mm in thickness in Pudong area particularly in the place close to Pudong International Airport. In result, the highway connecting the city to other places was completely closed. But the maglev train still ran normally and was not affected (Figure 1).

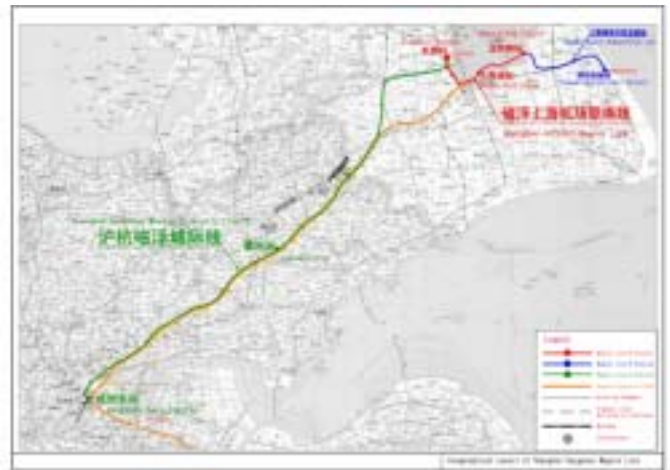
Figure 2. Layout of Shanghai-Hangzhou Maglev Line

To further verify the usability and economic efficiency of high speed maglev transportation in medium and long distance line with multi-stations and multi-sections, in March 2006, the Chinese government approved the project proposal for Shanghai-Hangzhou Maglev Project proposal; at present the engineering feasibility study for the project is being carried out. The line of Shanghai-Hangzhou Maglev Project will be 191km long in total (Figure 2) including the following new built stations: Shanghai South Station , Hongqiao Station, Jiaxing Station and Hangzhou East Station. It also includes the 31 km new-built airport link in Shanghai. Its highest speed for commercial operation will be 450km/h and the highest demonstration speed 500km/h.
